THE HISTORY AND SIGNIFICANCE OF CORING MASONRY WALLS

John Chrysler¹ and Kurtis Siggard²

ABSTRACT

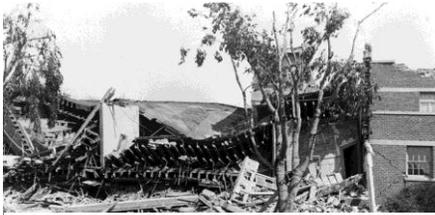
Figure 1: Jefferson Junior High School, Long Beach, California

Damage to schools was substantial with 300 schools experiencing minor damage, 120 schools with major damage, and 70 schools were entirely destroyed as depicted in Figure 1. If not for the event occurring at 5:55PM on a Friday evening, the loss of life would have been devastating. It was reported that there were more than 120 fatalities. [1]

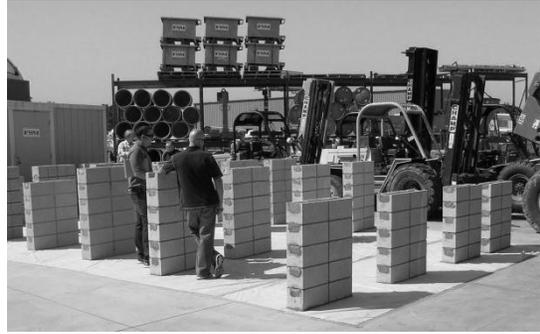
Figure 3: Masonry panels prior to grouting (bond beams mortared to restrict grout)

Panels were constructed in a stack bond configuration, 2 units in length, 6 or 7 courses (40 or 48 in.) in height. Bond beams were used to aid horizontal grout flow and the bond beam opening of the units at panel ends were mortared to confine grout. Reinforcement, which would have interfered with the core location selection, was not used in the panels. After construction, the panels were cured for 5 days before grouting. Figure 3 shows the panels prior to grouting.

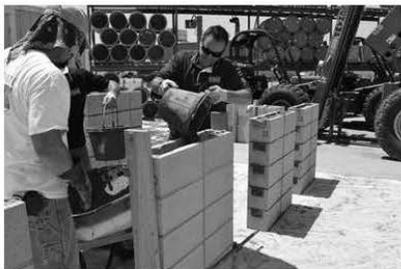
Figure 4: Bucketing Grout into Sample Panel

Grout was transported by wheelbarrow from the ready mix truck and buckets were used to grout the test panels as shown in Figure 4.

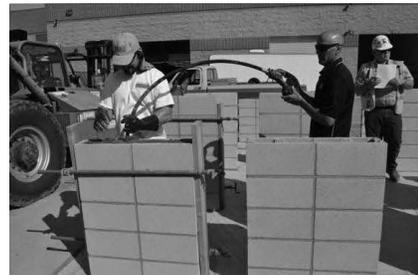
Figure 5: Consolidating Grout

Grout was mechanically consolidated and reconsolidated as shown in Figure 5 using a battery powered vibrator designed for consolidation of masonry grout. Reconsolidation was performed shortly after the initial consolidation and prior to the grout taking a plastic set. Due to ambient temperature, the time between consolidation and reconsolidation was relatively short.

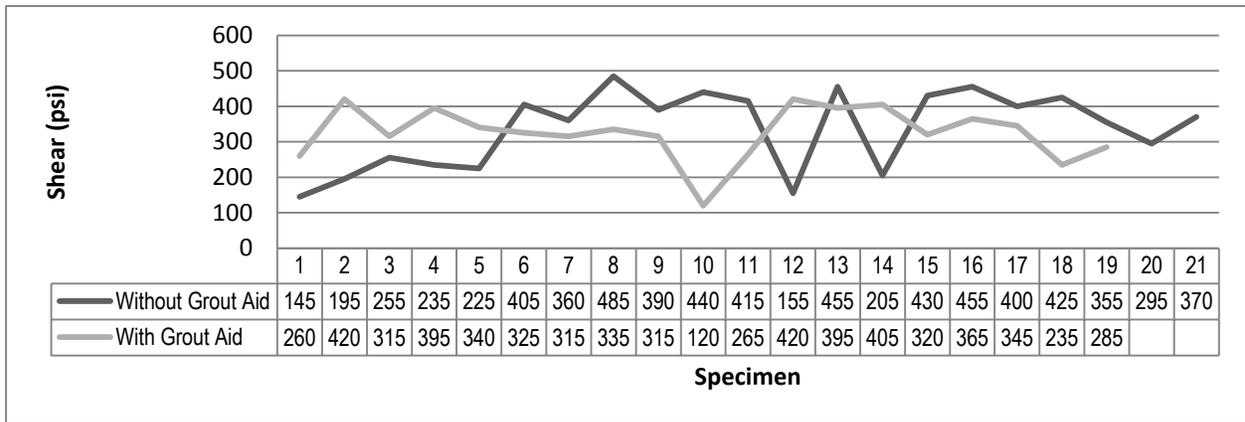
Figure 6: 7-Day Core Shear Test Results

The above results were analyzed and graphically sorted by core age, Figures 6 through 8. Although the shear values vary significantly, results show that the vast majority of shear values exceed the minimum requirement of the California Building Code. The value required by CBC Section 2114.9.3 or 2104A.4 is a shear bond equal or exceeding $2.5\sqrt{f'_m}$ psi, which correlates to 0.67 MPa (97 psi) when the f'_m is 10.3 MPa (1,500 psi). For sample panels 17 through 24, the f'_m was 14.5 MPa (2,100 psi) which requires a minimum shear bond value requirement of 0.79 MPa (115 psi).

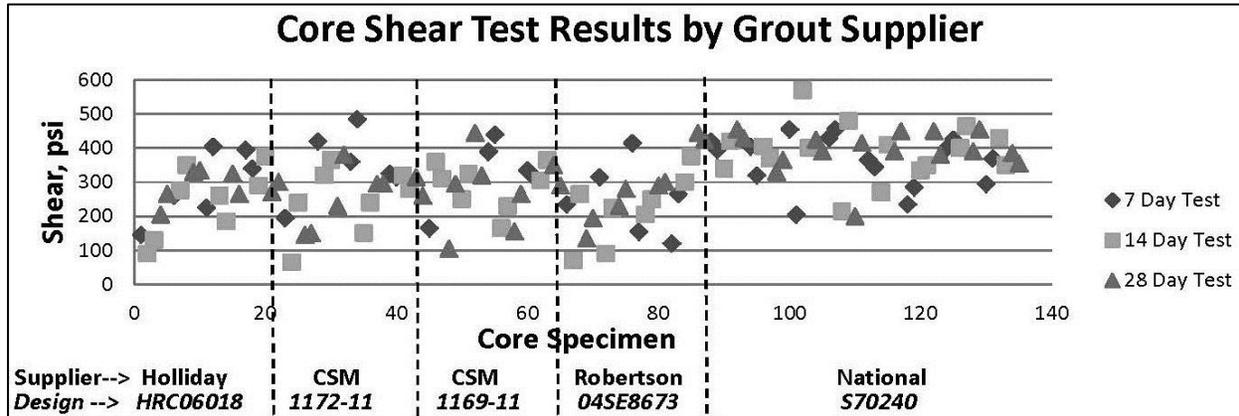
Figure 9: Core Shear Test Results by Grout Supplier

The data was also sorted by grout supplier, Figure 9, to see if there was any significant difference. Nearly all results were above 0.69 MPa (100 psi) with a significant majority above the 1.38 MPa (200 psi) level. Four of the five grout suppliers had similar results; however National Ready Mix had all results at or above 1.38 MPa (200 psi) shear value. Additionally, there were 48 core specimens representing National Ready Mix and of 96 face shells, 3 separated for a successful test rate of 97%.
