**PREFACE:** The following peer-reviewed technical paper was presented at the 12th Canadian Masonry Symposium, Vancouver, British Columbia, June 2, 2013. It is presented here in its entirety with permission from the authors.

### THE HISTORY AND SIGNIFICANCE OF CORING MASONRY WALLS

**John Chrysler<sup>1</sup> and Kurtis Siggard<sup>2</sup>**

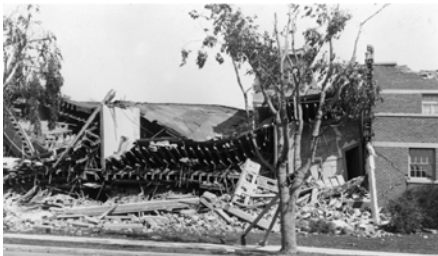
Figure 1: Jefferson Junior High School, Long Beach, California

During this period, along comes the Long Beach, California Earthquake. This March 10, 1933 earthquake, with a Moment Magnitude 6.3, was not huge, but it did register as VIII on the Modified Mercalli scale, with widespread damage and significant building collapse. [1]

Damage to schools was substantial with 300 schools experiencing minor damage, 120 schools with major damage, and 70 schools were entirely destroyed as depicted in Figure 1. If not for the event occurring at

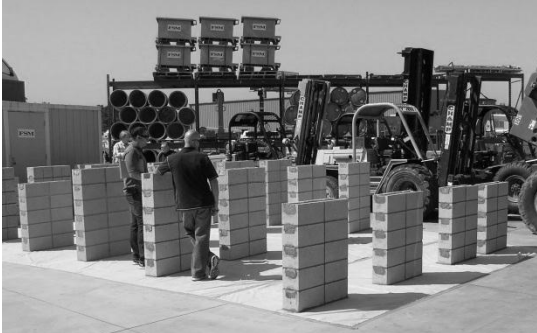
Figure 3: Masonry panels prior to grouting (bond beams mortared to restrict grout)

Panels were constructed in a stack bond configuration, 2 units in length, 6 or 7 courses (40 or 48 in.) in height. Bond beams were used to aid horizontal grout flow and the

bond beam opening of the units at panel ends were mortared to confine grout. Reinforcement, which would have interfered with the core location selection, was not used in the panels. After construction, the panels were cured for 5 days before grouting. Figure 3 shows the panels prior to grouting.

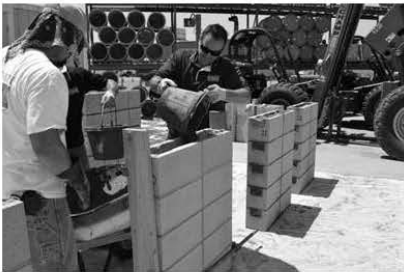
Figure 4: Bucketing Grout into Sample Panel

Grout was transported by wheelbarrow from the ready mix truck and buckets were used to grout the test panels as shown in Figure 4.

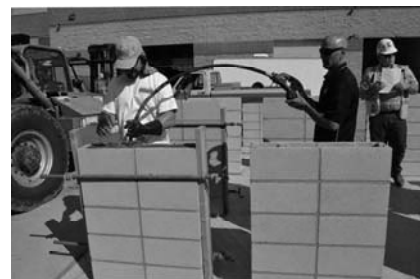
Figure 5: Consolidating Grout

Grout was mechanically consolidated and reconsolidated as shown in Figure 5 using a battery powered vibrator designed for consolidation of masonry grout. Reconsolidation was performed shortly after the initial consolidation and prior to the grout taking a plastic set. Due to ambient temperature, the time between consolidation and reconsolidation was relatively short.

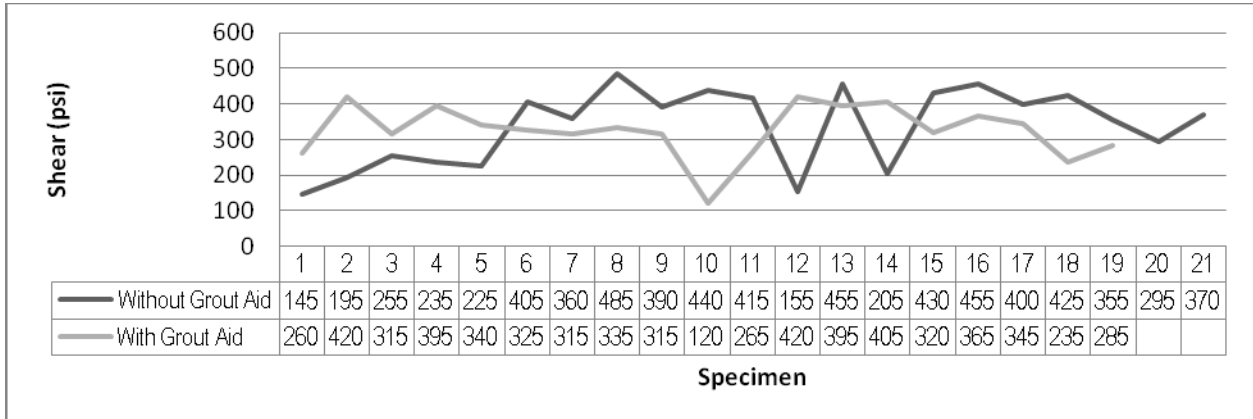
Figure 6: 7-Day Core Shear Test Results

The above results were analyzed and graphically sorted by core age, Figures 6 through 8. Although the shear values vary significantly, results show that the vast majority of shear values exceed the minimum requirement of the California Building Code. The value required by CBC Section 2114.9.3 or 2104A.4 is a shear bond equal or exceeding  $2.5\sqrt{f'_m}$  psi, which correlates to 0.67 MPa (97 psi) when the  $f'_m$  is 10.3 MPa (1,500 psi). For sample panels 17 through 24, the  $f'_m$  was 14.5 MPa (2,100 psi) which requires a minimum shear bond value requirement of 0.79 MPa (115 psi).
